SIGNATURE INSPECTIONS LLC.

Sample Report

PROPERTY INSPECTION REPORT FORM

Property inspected was: Vacant	Parties present at inspection:
Arrived:	Departed :
House information: Approx. Sq. Ft 3517	Approx. Yr Built

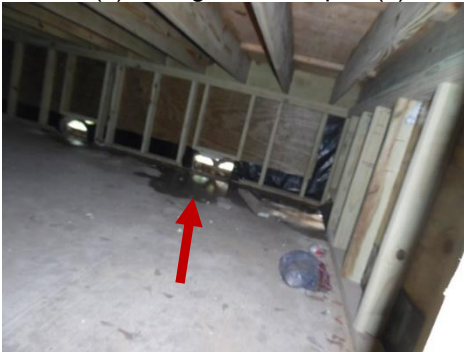
Water was observed entering the crawl space through the vents from the sprinkler system on the rear of the house.

Water from sprinkler system

You may want to consider readjusting sprinkler heads.

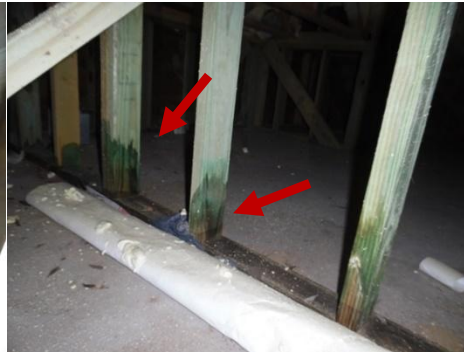
What appeared to be moisture stains were observed on the bottom of the framing in the crawl space.

The stains were dry at the time of inspection, the source of the stains is unknown and should be identified and repaired if needed.

moisture stains

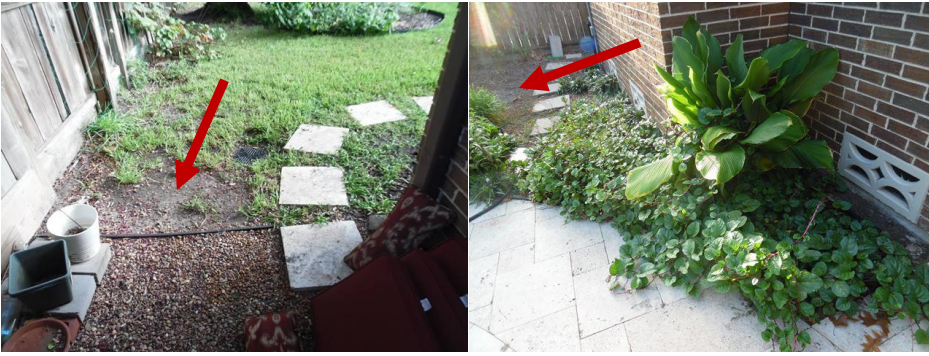
Evidence of previous water ponding on both sides of the structure by the fence and gate, and at the left rear corner of the structure were observed monitoring the areas to determine if repairs are needed is recommended.

Possible ponding area

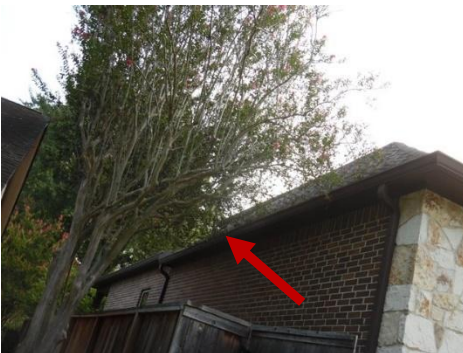
Tree limbs were observed touching the roof surface, the tree limbs should be trimmed off of the roof to prevent damaging the shingles.

Trim trees

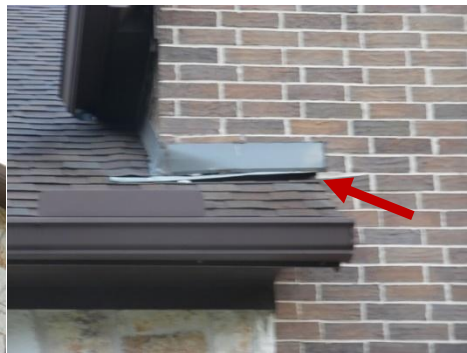
Raised roof line flashing was observed on the roof above the right side of the garage door, a repair is needed.

raised roofline flashing

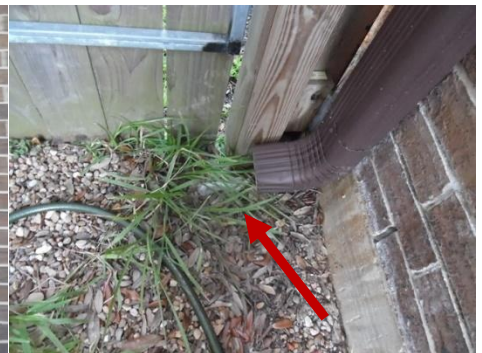
A splash block is missing on the front right corner of the house, the splash blocks help prevent soil erosion next to the foundation.

no splash block

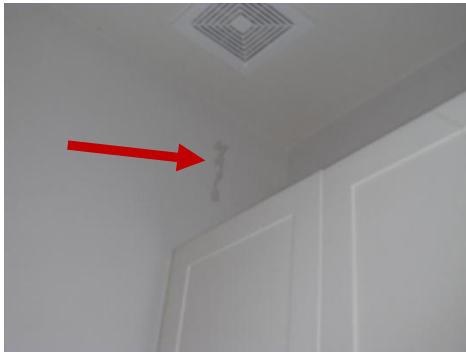
Areas of the interior of this structure appear to have been freshly painted. True condition of surface exterior may be concealed at this time. It is beyond the scope of this inspection to determine the conditions below the surface of the paint. There is an unidentified stain at the top of the wall above the cabinet in the downstairs hall bathroom.

The source of the stain is unknown and should be identified and repaired if needed.

Unidentified stain

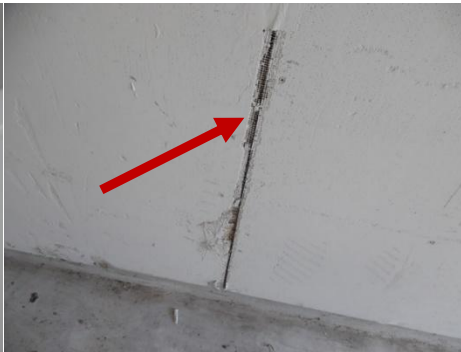
Sheetrock seams in the garage have not been properly taped and floated and a trap cap is not properly secured to the wall.

sheetrock not taped and floated

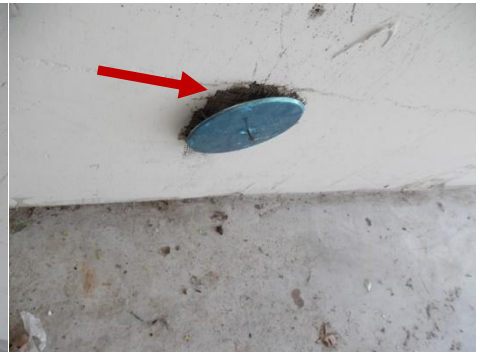
trap cap not secured to wall

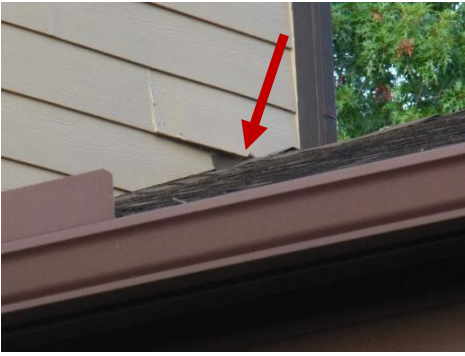
What appears to be evidence of a previous Hardy board repair was observed above the Ridge on the back porch roof.

Previous repair ????

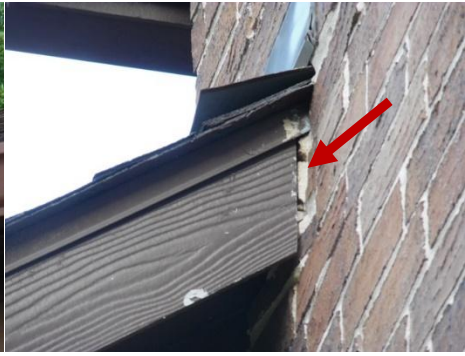
The fascia board is too short on the front of the house above the right side of the garage door.

Fascia board too short

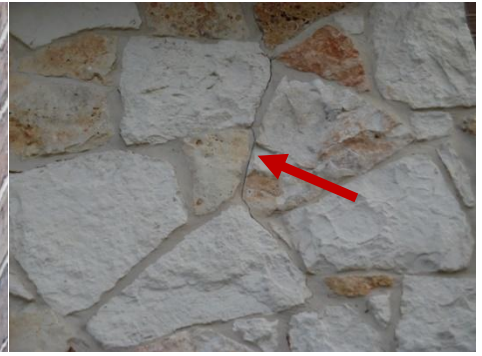
A slight stone mortar separation was noted above the garage door. Typical observation for a structure this age.

typical settling

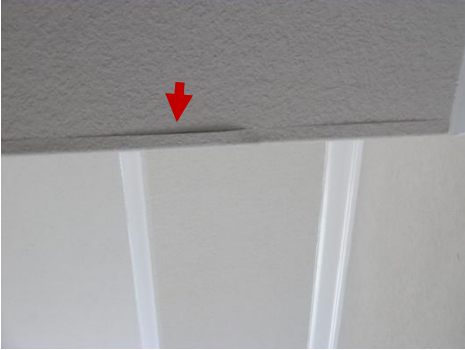
What appears to be a typical bull nose corner bead settling seam was observed on the hall ceiling to the dining room.

Bull nose settling

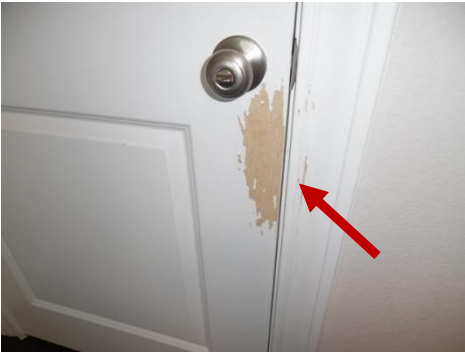
The paint is damaged on the upstairs left bedroom door.

Damaged paint

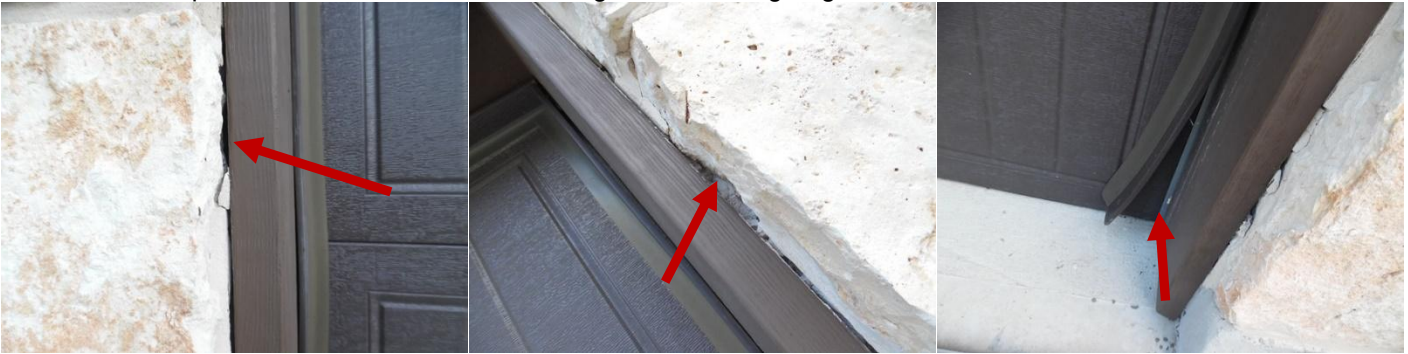
There is no caulk in the gap between the garage side door trims and the stone sheathing. Caulking, and sealing the gap is recommended to prevent the possibility of moisture, and insect penetration. The weather strip has come loose on the bottom right side of the garage door.

Gap is not caulked and sealed

loose weather strip

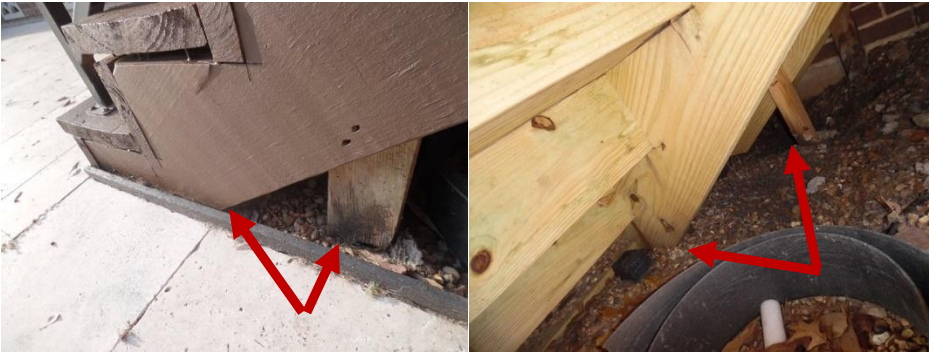
This is a conducive condition that could attract wood destroying insects, and premature deterioration of the material.

Wood to soil contact

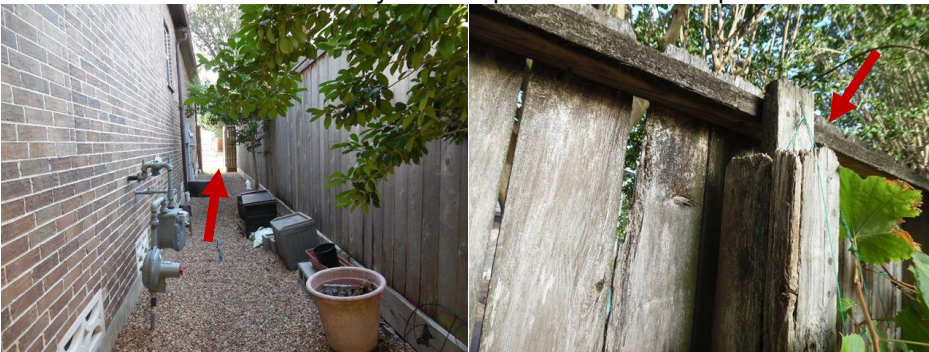
No child Safety gate latch (self-closing and locking gate closer) was observed on the gate.

Several areas of the fence in the backyard or either damaged, or leaning

No child Safety latch on gate

damaged fence

Repairs are recommended for the fence in the backyard.

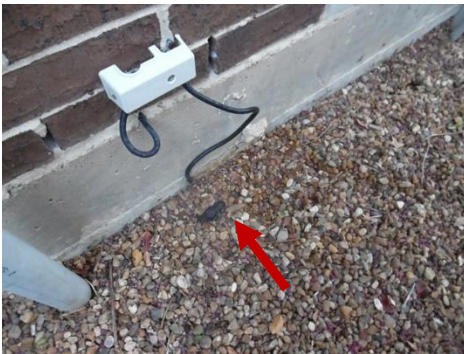
The ground rod connection is below grade level, raising the connection above the soil is recommended to prevent rust and corrosion on the connection.

Ground rod connection below grade

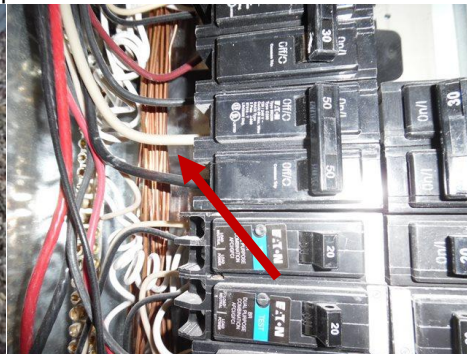
White wires are known to be identified as neutrals. The white wire on A 2 pole breaker for a 220-volt circuit should be color coded as a hot wire with black or red tape.

put black tape on white wire

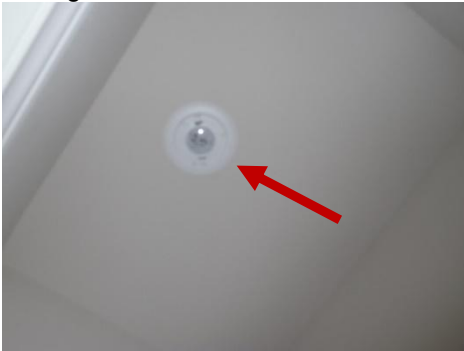
The light fixture in the closet in the first-floor front right bedroom is missing.

Light fixture is missing

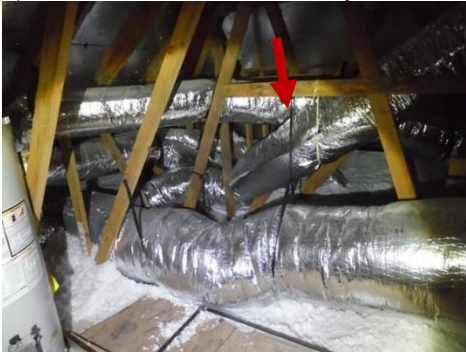
Areas of the duct work are touching each other. This may cause a condensation issue. Separating the duct work or insulating the duct work from each other is recommended.

Ducts touching

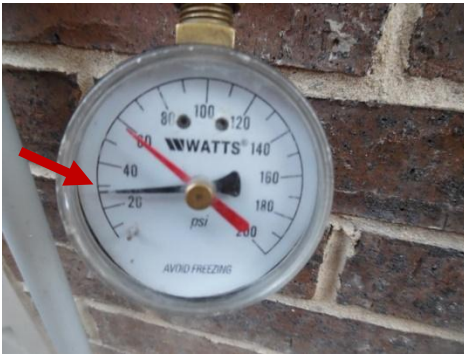
Low water pressure

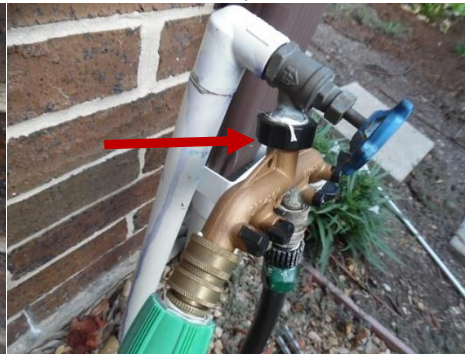
Anti Siphon / Back Flow / Air Gap(s): Missing on some outside faucets

no anti siphon device

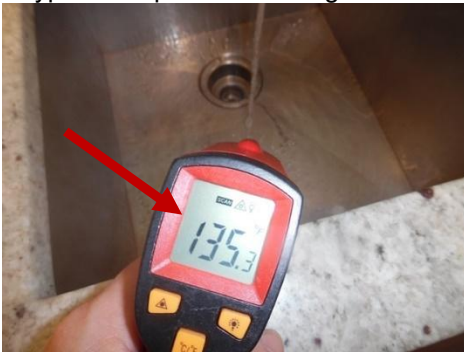
The water temperature at the kitchen sink measured 135 degrees.

A typical temperature setting on the water heater is 120 degrees.

Kitchen sink water temperature

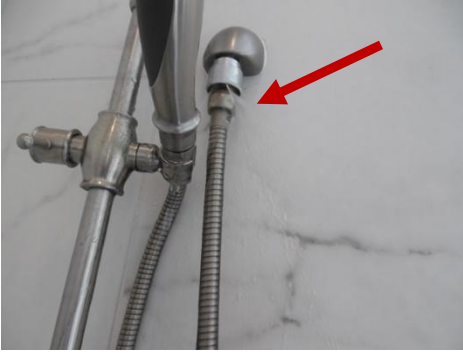
Shower: The shower head hose connection leaks when in use.

Hose connection leaks

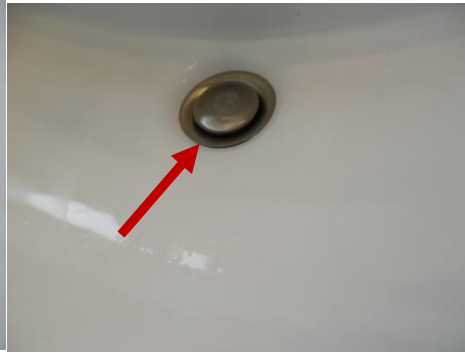
stopper did not seal

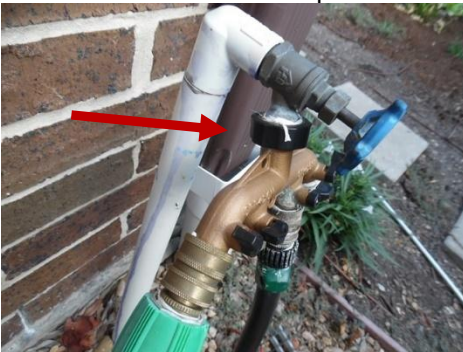
No anti-siphon protection was observed on right rear corner exterior hose bibs/faucets. This is a basic safety attachment to the end of faucets that will protect from a cross connection or back-flow of water into the house.

Same faucet no anti siphon device

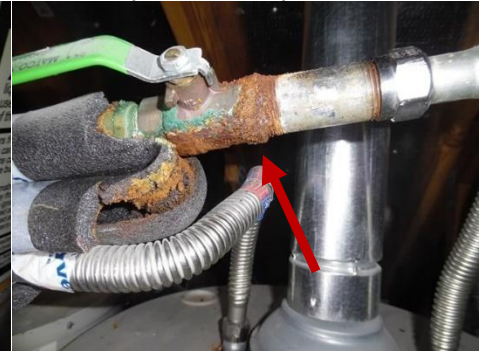
Main water valve is rusted and corroded on the right unit.

rusted and corroded water valve

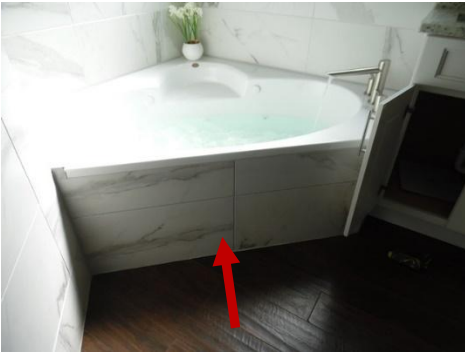
No pump and motor access

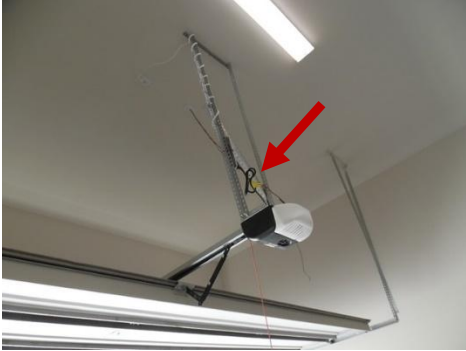
The door opener is powered with an extension cord power strip.

Extension cords are not an approved source of permanent power.

Extension cord power strip

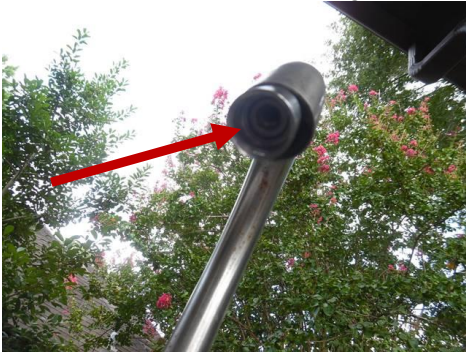
Aerator screen missing

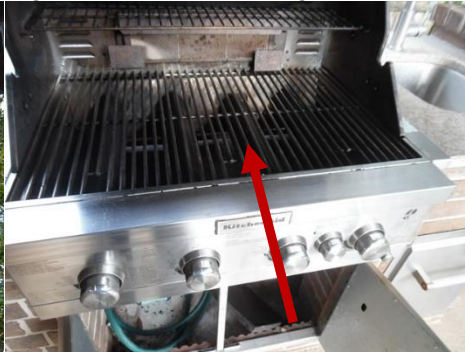
grill did not light

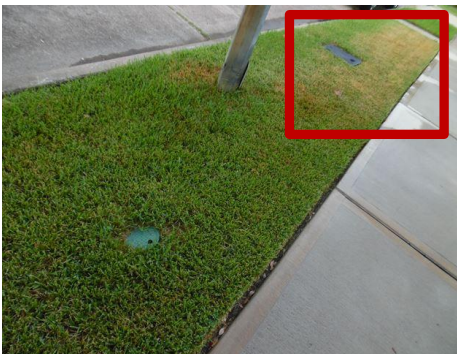
No sprinkler heads observed

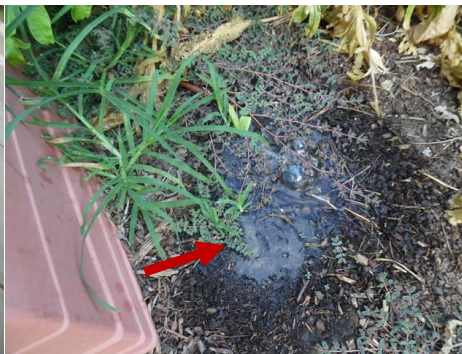
head bubbling from underground

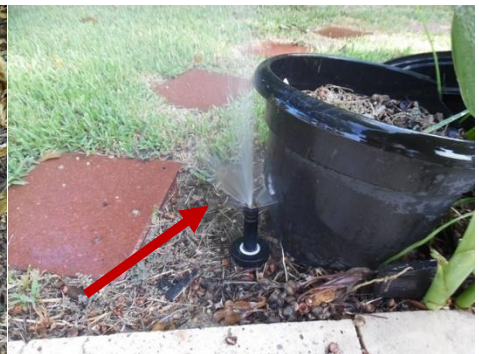
sprinkler head shooting straight up
